Structural separating floor - Timber (existing)

PCT solution

Design & installation details - PCT refurbishment treatments

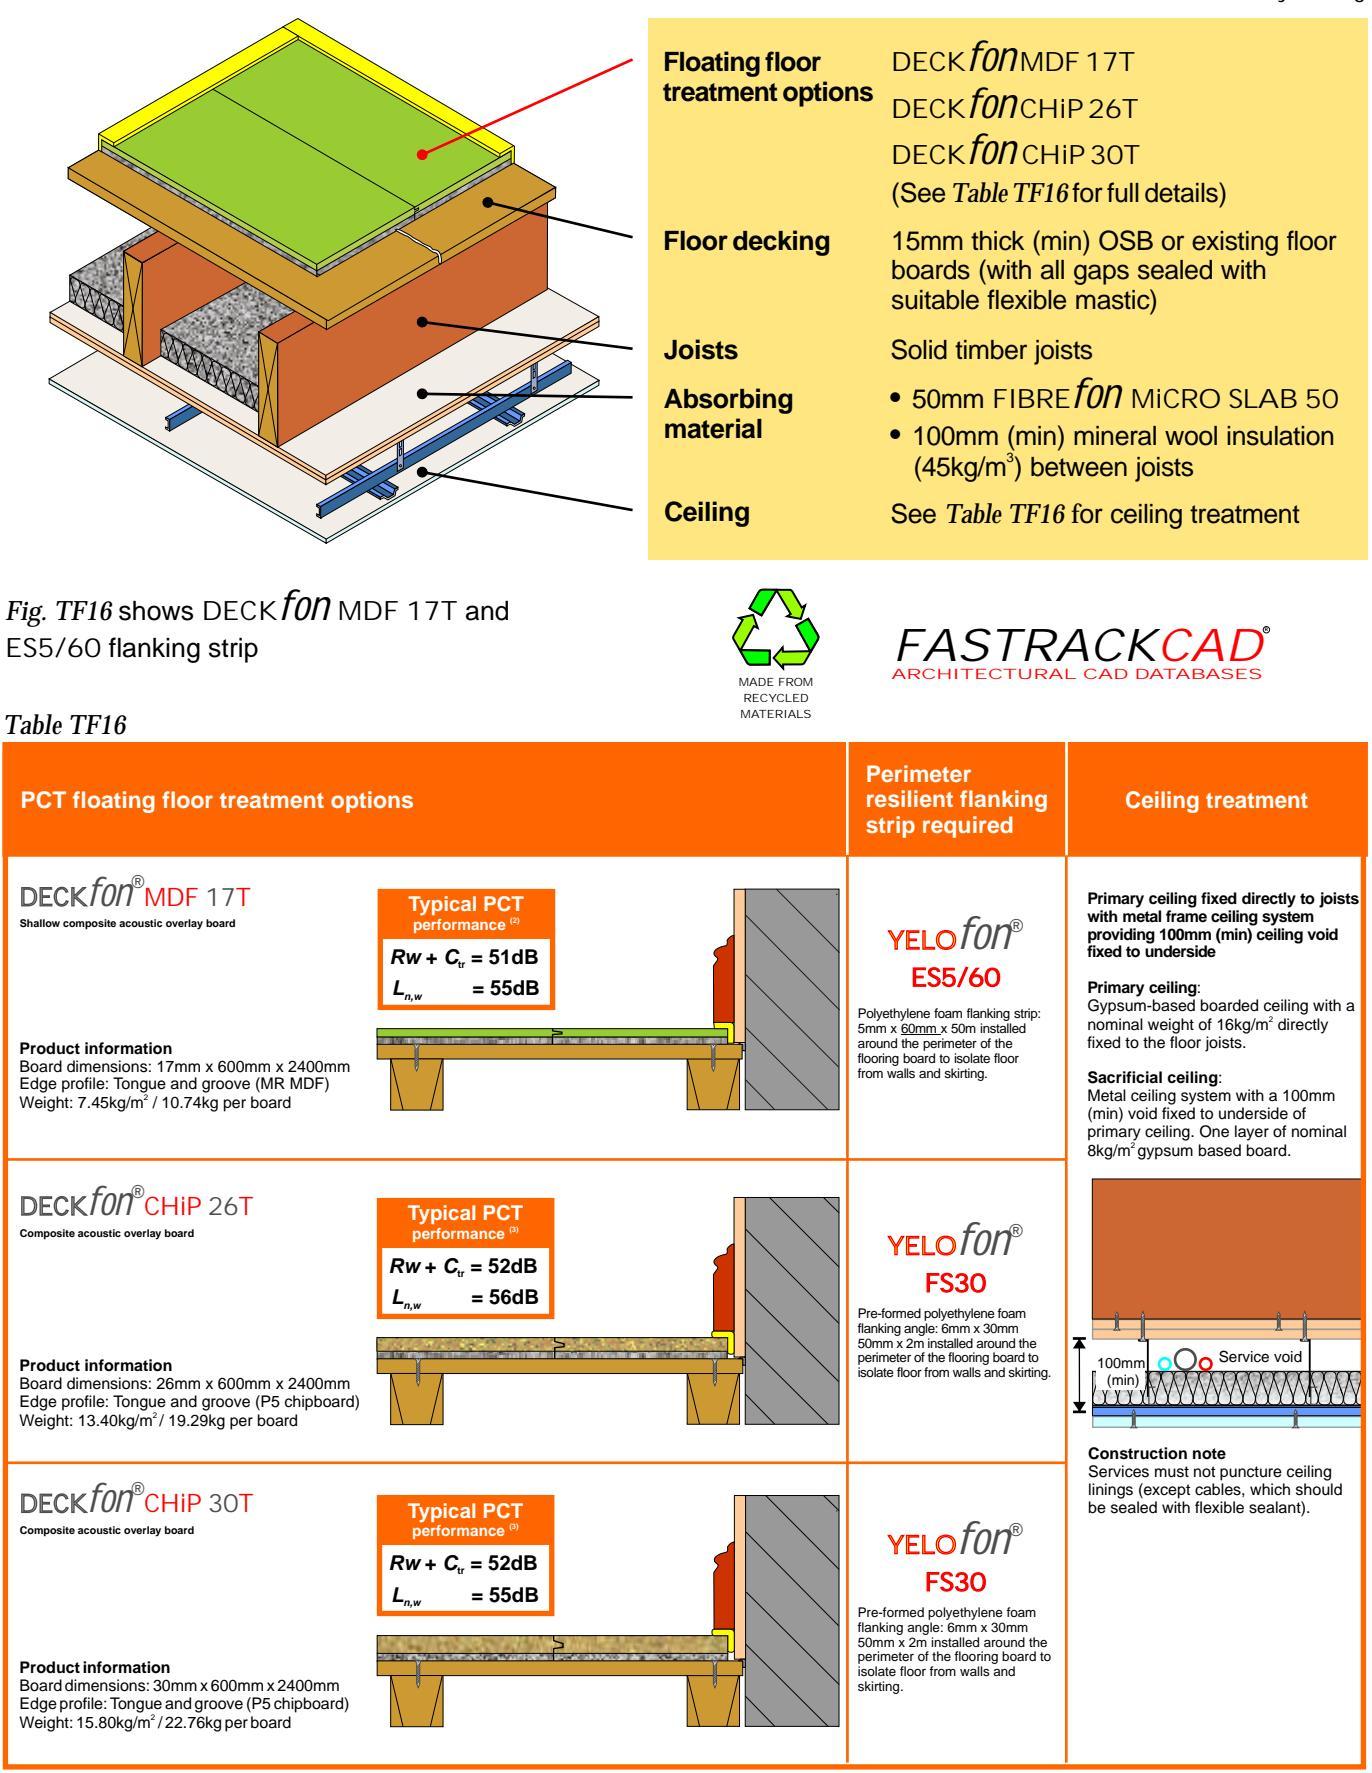
Existing timber joists Acoustic treatment laid on sub-floor Metal frame secondary ceiling

Materials must be installed in accordance with manufacturers' instructions to achieve stated acoustic values. Wall treatments <u>MUST</u> be isolated from the floating floor with YELOfon flanking strip. Ensure services do not come into contact with the floor treatment. Once laid, MDF17T boards should be covered with the final floor finish as soon as possible to eliminate the risk of mechanical damage to the edge detail. Acoustic values

³⁰ Test data quoted was conducted in a UKAS accredited laboratory in accordance with Approved Document E: Annex B: Procedures for sound insulation testing. Airborne results tested in accordance with BS EN ISO 140-3:1995 Impact results tested in accordance with BS EN ISO 140-6: 1998

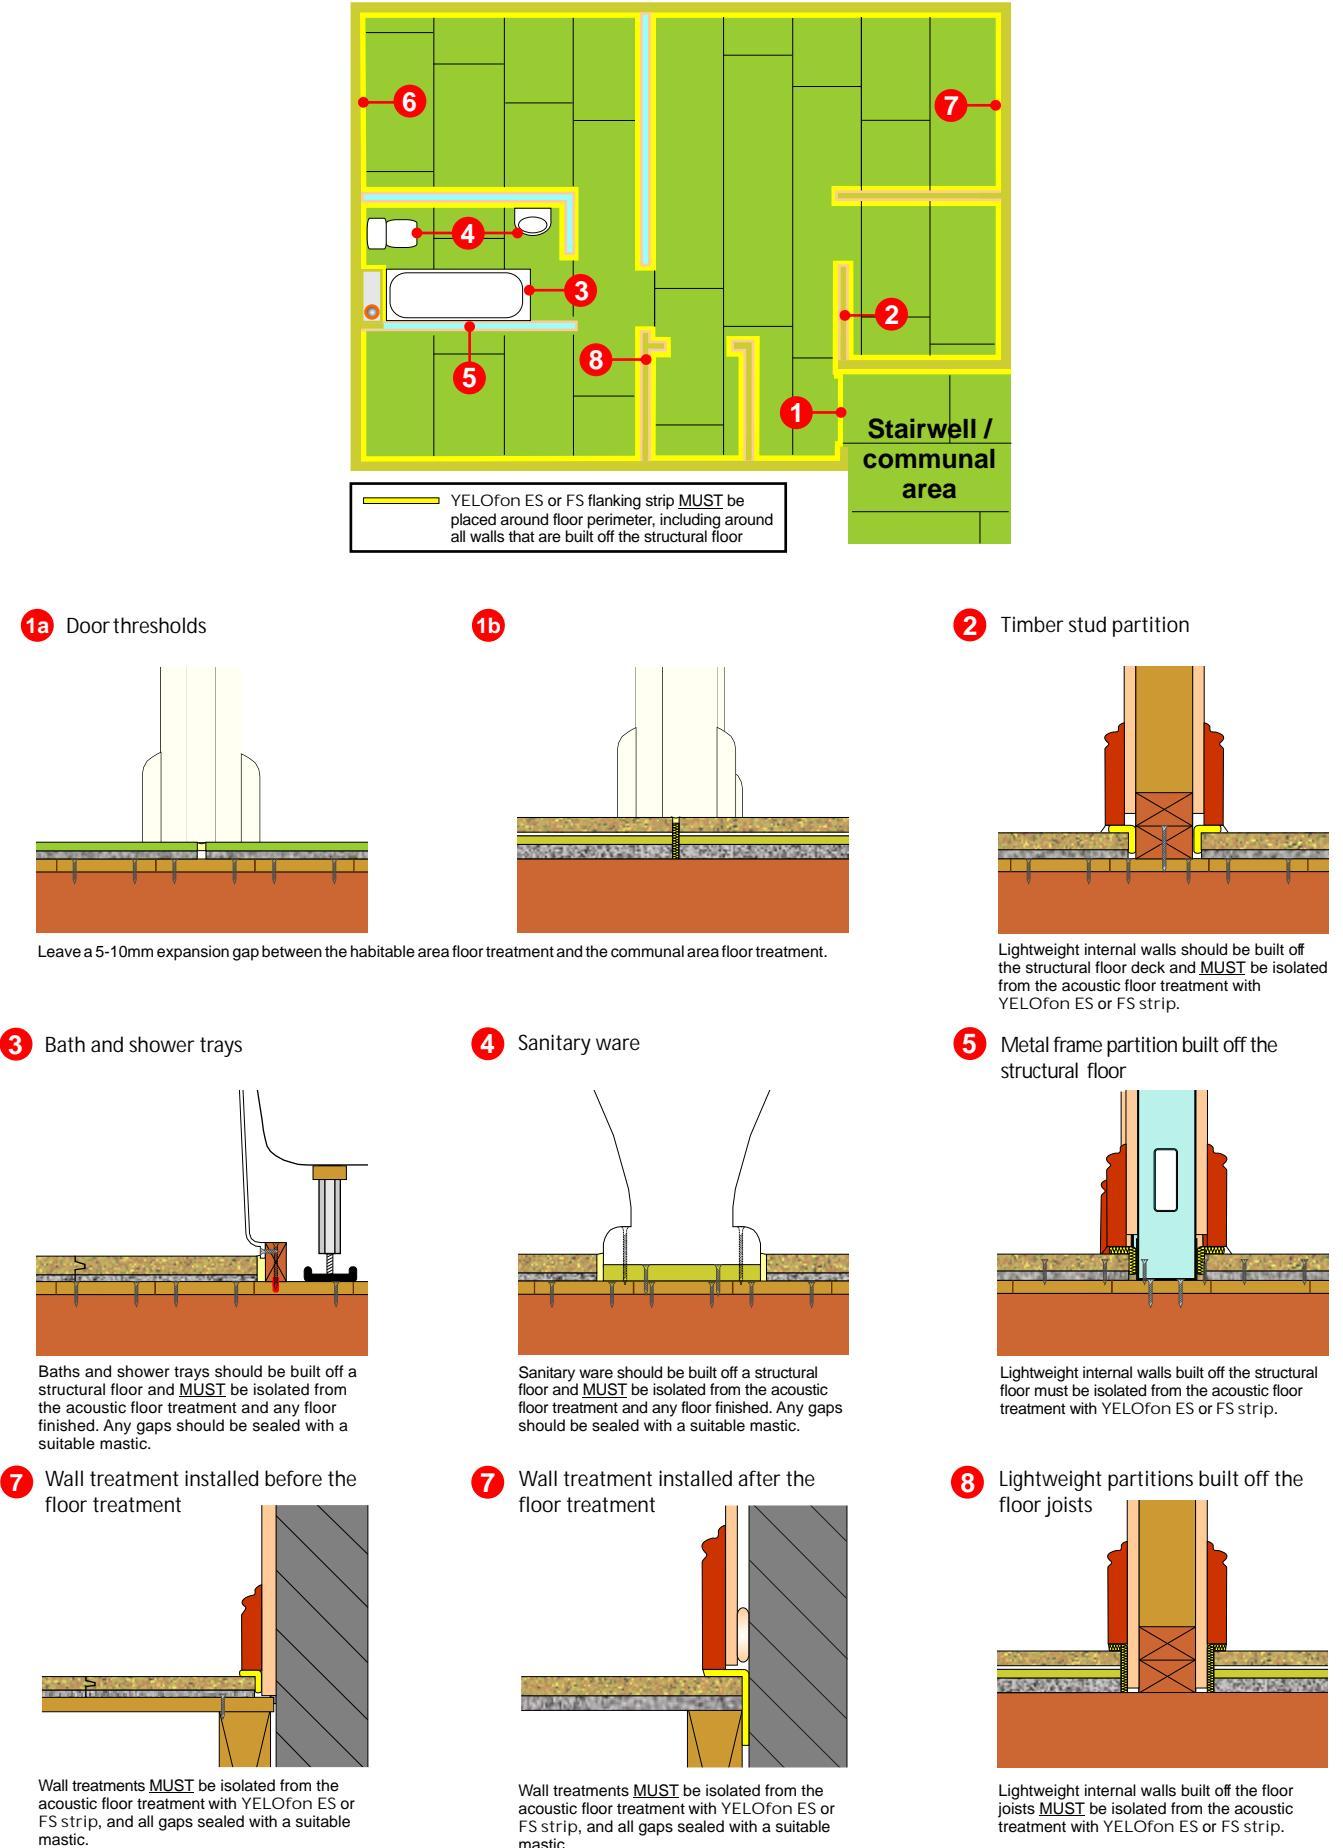
DECKFOP®CHIP 26T Composite acoustic overlay board	Pinter State	YELO FOID® FS30 the-formed polyethylene foam anking angle: 6mm x 30mm 0mm x 2m installed around the erimeter of the flooring board to solate floor from walls and skirting.	Construction note Services must not puncture ceiling linings (except cables, which should be sealed with flexible sealant).
DECKFOP®CHIP 30T Composite acoustic overlay board	Pinter State	YELO FOID® FS30 Pre-formed polyethylene foam anking angle: 6mm x 30mm omm x 2m installed around the erimeter of the flooring board to solate floor from walls and kirting.

The acoustic performance of the floor structure will be compromised if the acoustic treatment is not completely isolated from the timber joists, sub-floor, services, door frames, surrounding walls and their treatments. To address this risk, each potential problem area needs to be detailed accordingly.
